June 30, 2021

DCW Counterweight

Support Angles

SUMMARY

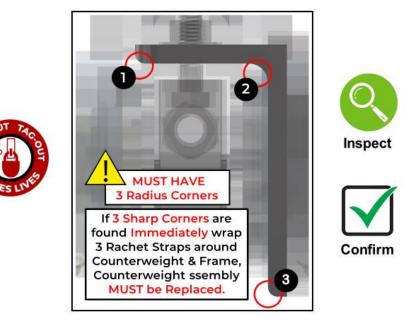
Inspection Required Prevent Injury & Death Prevent Damage & Liability MUST Have 3 Radius Corners If 3 Sharp Corners Are Found, Call Tech Support for IMMEDIATE Replacement

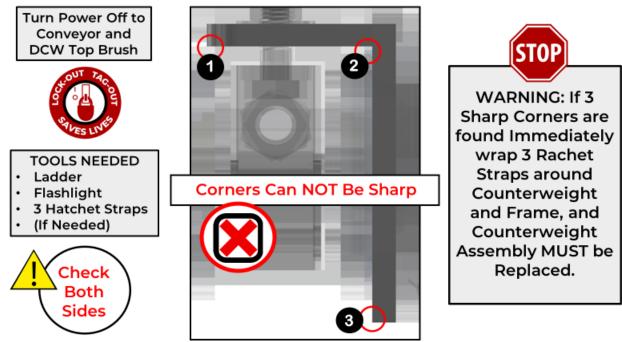
WARNING: To PREVENT an accident that might result in personal injury, death, and/or dismemberment, as well as vehicle, property, and equipment damages and/or failure; the Component on the Counterweight Weldment that attaches to the Aluminum H-Frame MUST have 3 Radius Corners as shown in this Technical Bulletin. If it does NOT, 3 Ratchet Straps MUST Be Installed IMMEDIATELY as a Preventive Measure and the Counterweight Assembly MUST be Replaced.

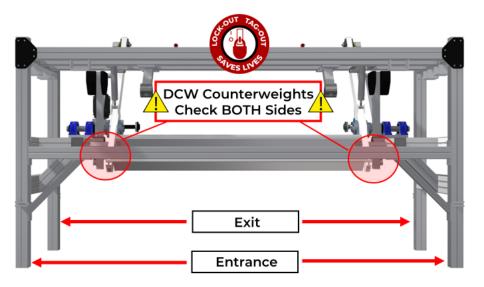
- 1. DCW Top Brush MUST be in the Retracted Position. Turn off power to conveyor and DCW Top Brush.
- 2. With the Brush Retracted, inspect the DCW Counterweight Assembly; and Facing towards the Exit of the Tunnel, inspect the Entrance Side of the DCW Top Brush. Inspect Both Sides.

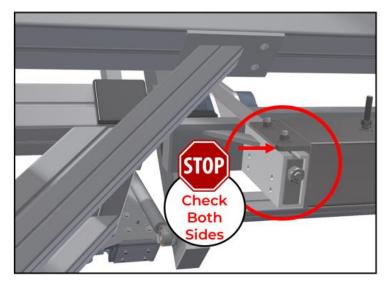
3. Using a ladder, get close to the Counterweight Assembly and look at where the Stainless Steel Angle attaches to the Aluminum H-Frame.

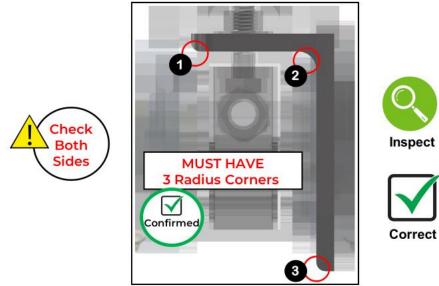
4. If the Counterweight Assembly Component has a Structural Angle with <u>3 Radius Corners</u>, the Support Angles are <u>Correct</u>.

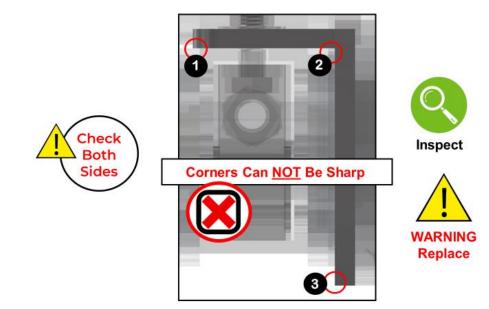
5. If the Counterweight Assembly Component has an Architectural Angle with <u>3 Sharp Corners</u>, the <u>Counterweight</u> Assembly <u>MUST Be Replaced</u>.

WARNING: If inspected Counterweight Assembly Support Angles have an Architectural Angle (3 sharp corners), please call Sonny's Technical Support Team IMMEDIATELY to set up an appointment to replace the Counterweight Assembly.

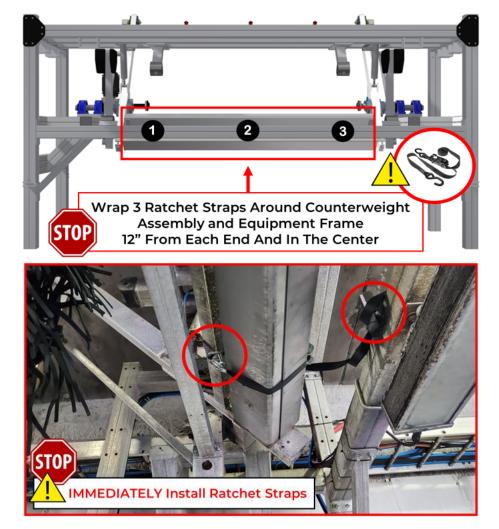
WARNING: 3 Ratchet Straps MUST Be Installed IMMEDIATELY if the Counterweight Assembly Support Angles have an Architectural Angle (3 sharp corners); to prevent an accident. This MUST be done as a Preventive Measure until the Counterweight Assembly can be Replaced.

6. As a Safety Precaution, wrap 3 Ratchet Straps around Counterweight Assembly and Equipment Frame, 12" from each end and in the center.

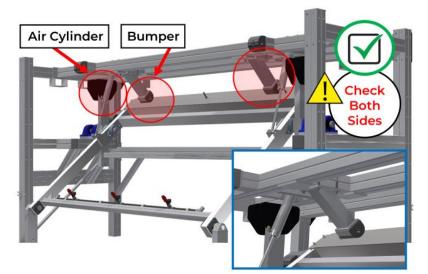
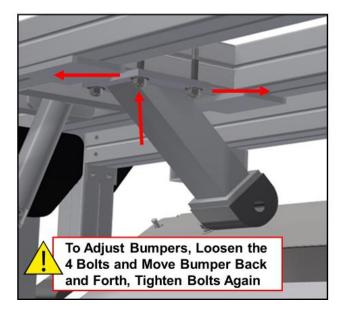
7. Check that Adjustable Bumpers are set up properly and Air Cylinder is NOT bottoming out in the stroke.

IMPORTANT: When the Top Brush comes down to wash a vehicle, the Bumpers should contact the Counterweight Assembly and allow for compression of the Bumper before the Air Cylinder reaches the end of the stroke. To adjust, loosen the 4 Bolts that clamp the Bumper Assembly to the Cross Header. Once loose, slide back and forth to bring closer or further from the Counterweight Assembly.

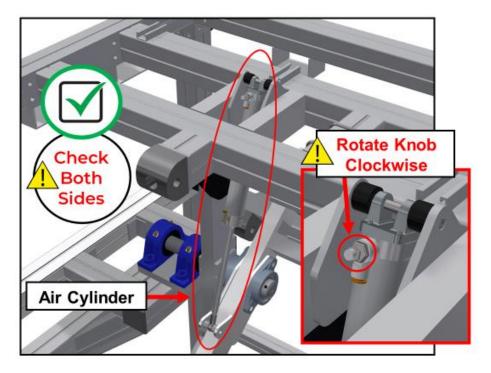
- 8. Air Pressure and Flow Rate MUST be inspected and adjusted if necessary. Retract motion MUST be smooth and come to a stop without bouncing off the Bumpers or high velocity impact to Bumpers.
- 9. Increase Air Pressure until Top Brush fully retracts.
- 10. Adjust Flow Control using Needle Valve on the Exhaust Port of the Air Cylinder, rotate the Knob clockwise to slow down the retract speed. Adjustments should be the same on both Air Cylinders.

IMPORTANT: Air Pressure MUST ONLY be used for retracting and NOT for washing pressure.
